# Manhole Inspection Summary

Manhole # S15EE\_035MH

Record Plat: **15EE** Node: **035** Status: **Other (Specify in comment)** Insp Date: **7/31/09 9:46 AM**

**Paragraph 8 - New Manhole SC812**

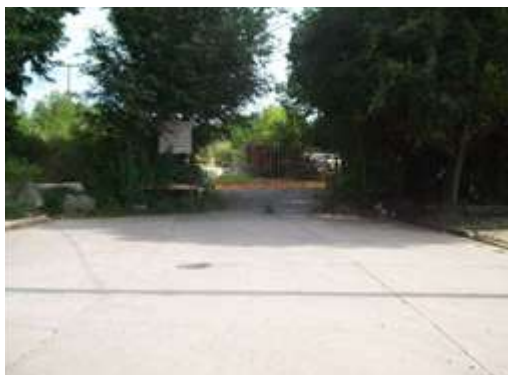
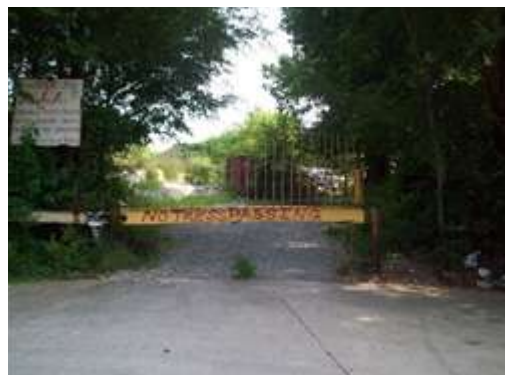
### Location View

GATE AT PRIVATE PROPERTY
